Manhole Inspection Summary

Manhole # S35Y__017MH

Insp Date: **5/12/09 2:31 PM**

Location Address: **1901 S CHARLES ST**

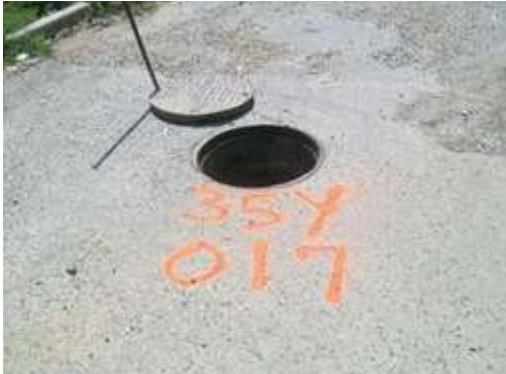
MISC.

PAVEMENT MARKED

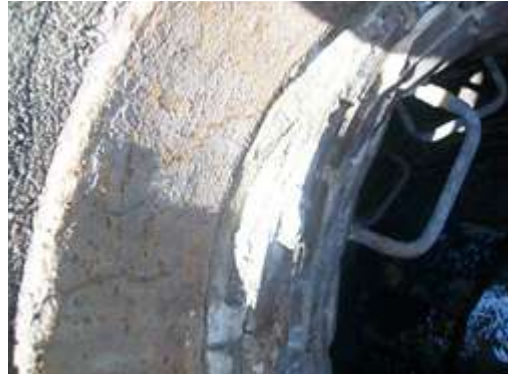
Defect 1

Offset: **2** (in.)

FRAME OFFSET

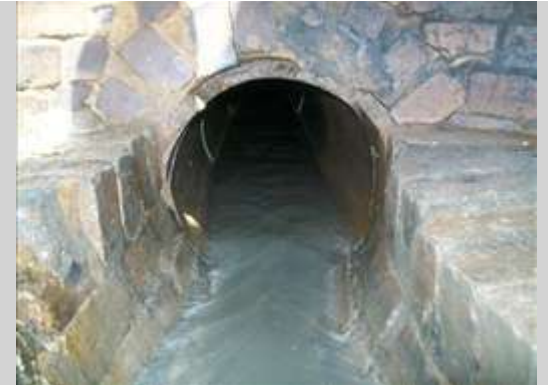
12 O'Clock Outflow

12 in. Circular Gravity Sewer
Pipe Out @ 12 O'Clock

Pipe Height: **12** (in.) Rod and Bar (Angled)
Pipe Material: **Clay** ☐ Pipe Lined
Invert Depth: **7.50** (ft.) Flow Characteristics: **Slow**
Deposits: ☒ None ☐ Mud ☐ Sludge ☐ Debris ☐ Grease
Silt Depth: **0** (in.) Deposits Extent:
Infiltration: **Weeper** Pipe Seal Cond: **Sound**

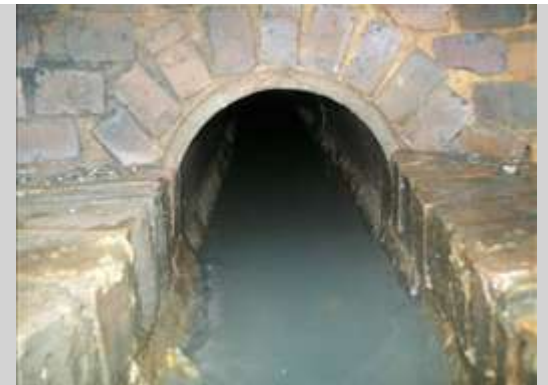
5 O'Clock Inflow

12 in. Circular Gravity Sewer
Pipe In @ 5 O'Clock

Pipe Height: **12** (in.) Rod and Bar (Angled)
Pipe Material: **Clay** ☐ Pipe Lined
Invert Depth: **7.44** (ft.) Flow Characteristics: **Slow**
Deposits: ☒ None ☐ Mud ☐ Sludge ☐ Debris ☐ Grease
Silt Depth: **0** (in.) Deposits Extent:
Infiltration: **None** Pipe Seal Cond: **Sound**

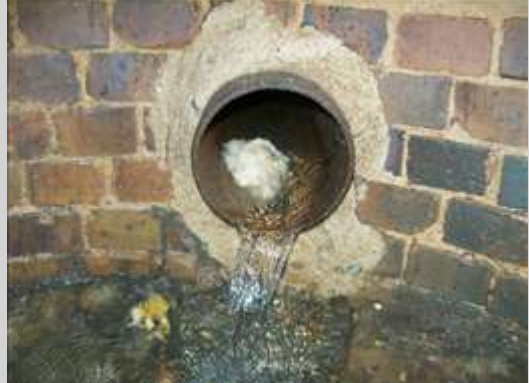
8 O'Clock Inflow

8 in. Circular Gravity Sewer
Pipe In @ 8 O'Clock

Infiltration: **None** Pipe Seal Cond: **Sound**
